COMMUNITY FACILITIES PLAN

TOWN OF TICONDEROGA

ALFANDRE ARCHITECTURE, PC
Creating spaces and places of lasting beauty
May 2013

EXISTING CONDITIONS ASSESEMENT AND CAPITAL IMPROVEMENT PLAN

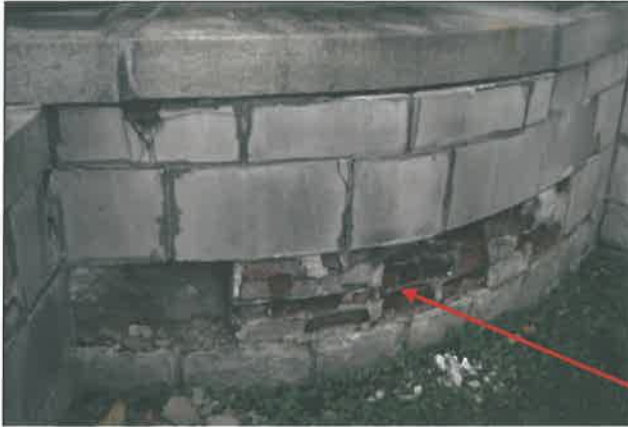
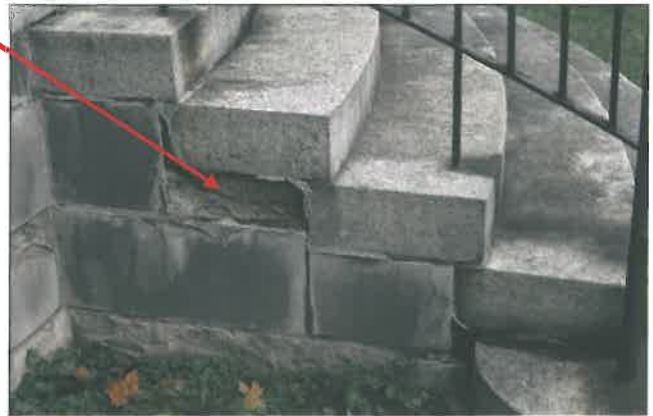
BUILDING ENVELOPE- EAST PORTICO

Repair stone walls around the east façade portico

Category	Priority	Item Description	Cost
SC	1	Repair stone walls near the southwest section of the building.	\$24,000
SC	1	Repair stone walls around the east façade portico.	\$56,000
BE	1	Repair the roof of the east façade portico.	\$3,400
EC	2	Caulk windows and doors to reduce infiltration.	\$4,900
Item Subtotal			\$88,300

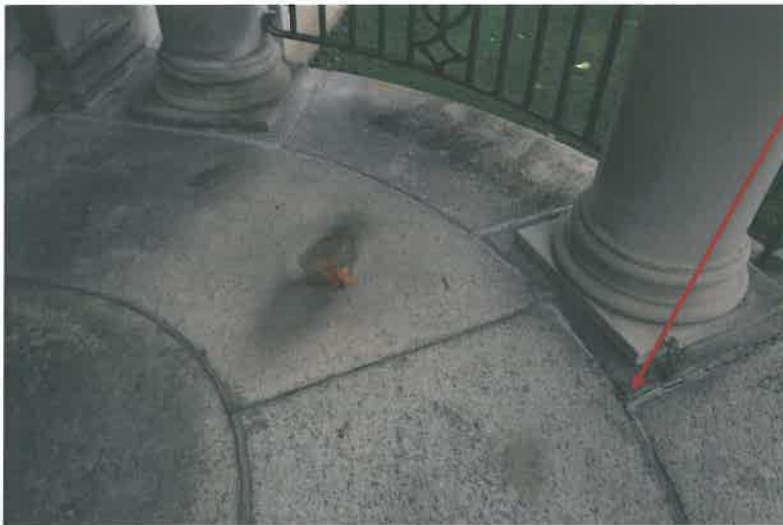
Clean and caulk floor of portico to prevent further infiltration

Repair the roof of the east façade portico.

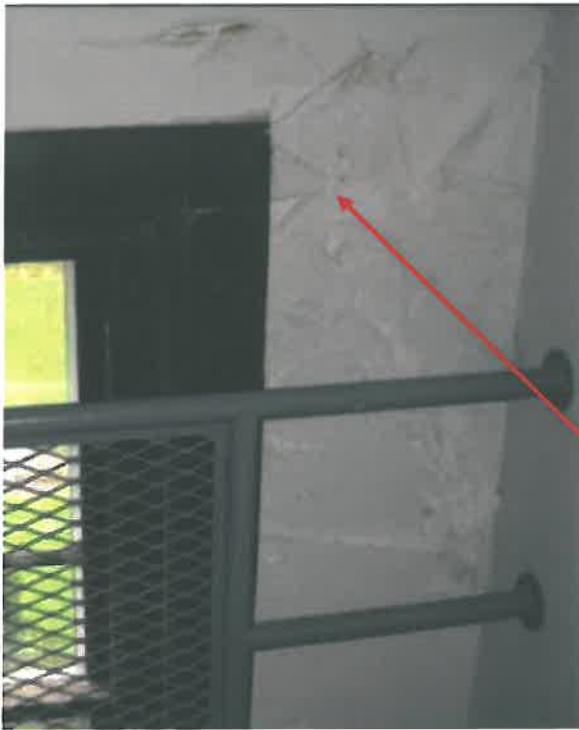
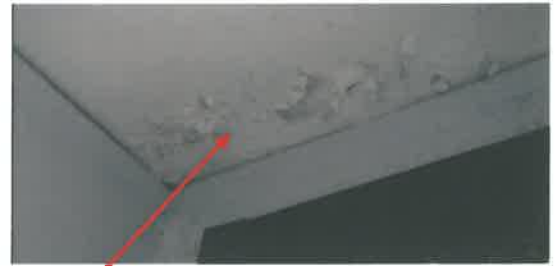
Repair roof on the northwest corner of building in or near to the cupola to prevent water damage to the interior spaces.

Category	Priority	Item Description	Cost
SC	1	Direct rainwater away from the southwest section of the building envelope to prevent boiler room flooding.	\$7,600
BE	1	Repair roof on the northwest corner of the building in or near to the cupola to prevent water damage to the interior spaces.	\$3,600
BE	2	Air seal the roof and attic penetrations to reduce infiltration.	\$17,300
HSWP	2	Perform asbestos abatement in the portions of the basement insulation that contain it.	\$20,200
EC	3	Persue NYSEDA energy conservation incentives for lighting retrofits.	\$2,200
MS	2	Provide or upgrade air conditioning.	\$59,600
MS	2	Renovate Meeting Room HVAC.	\$9,500
Item Subtotal			\$120,000

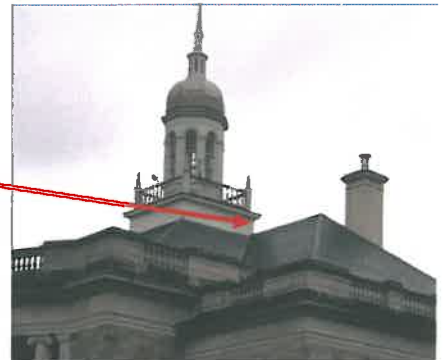
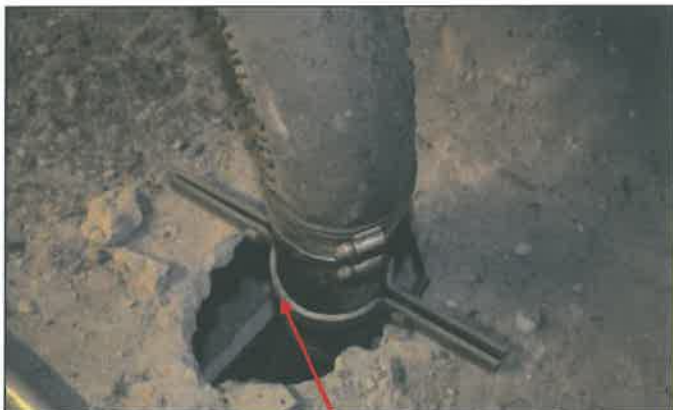
Air seal the roof from inside the attic space and where pipes penetrate the attic floor slab to reduce infiltration.

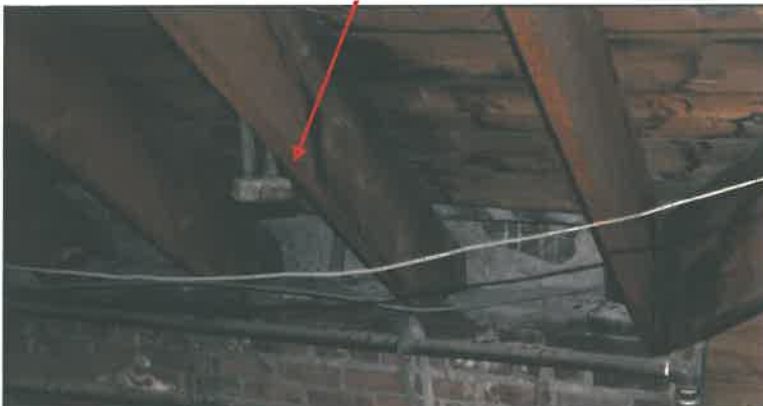
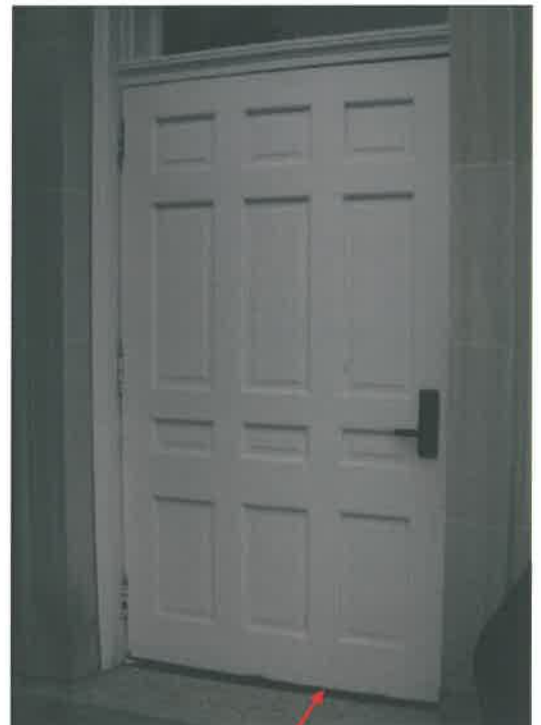
Reinstall west façade entry door for better closure.

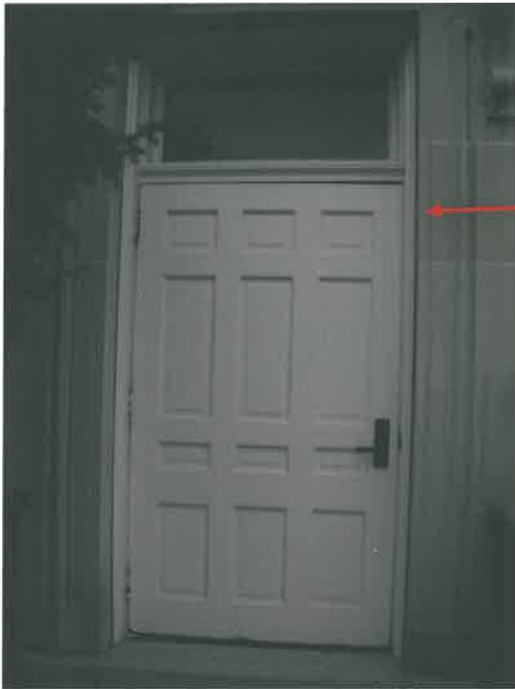
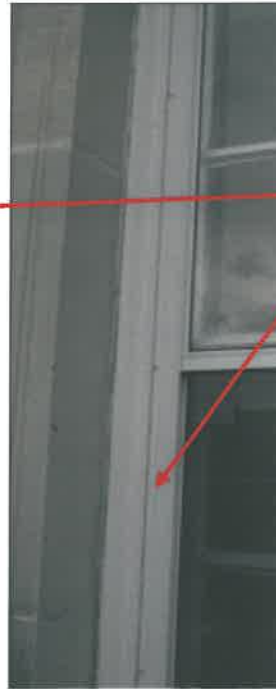
Caulk windows and doors to reduce infiltration

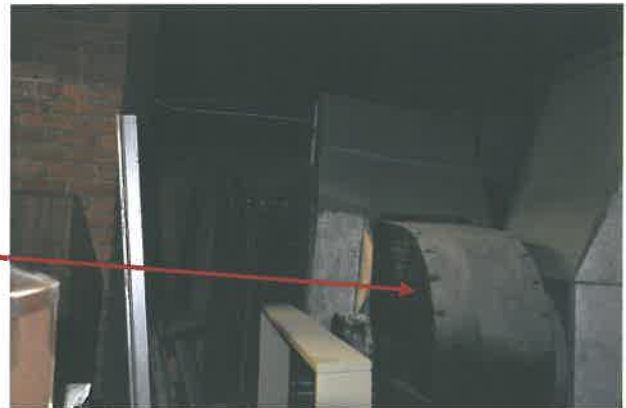
Heating System- Convert steam to hot water heating.

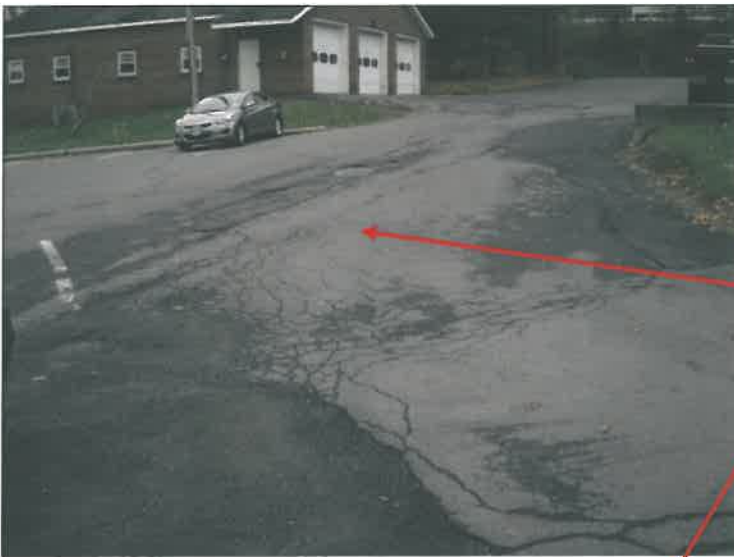
The slope of the parking lot adjacent to the southwest section of the building directs rain water runoff towards it periodically flooding the boiler room.

NOTE: The area adjacent to the building needs to be re-contoured to direct water away from the building.

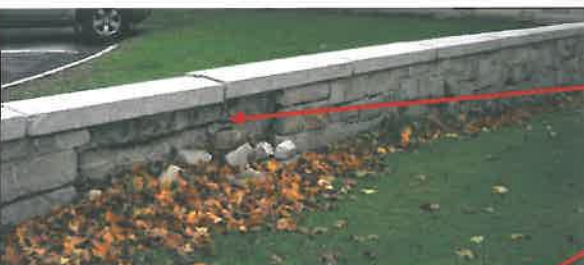
Repair stone walls near the southwest section of the building.

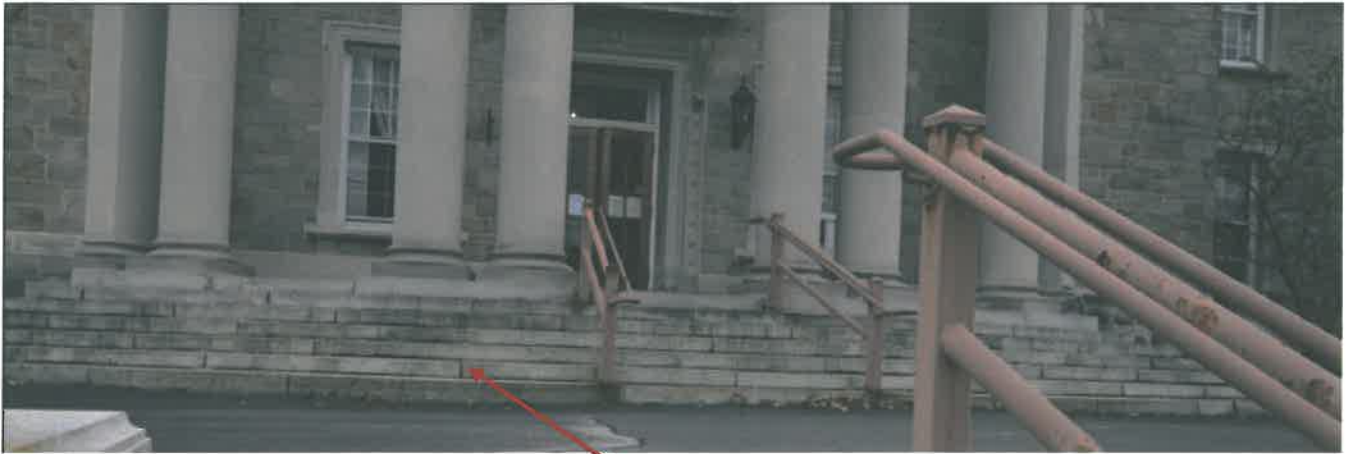
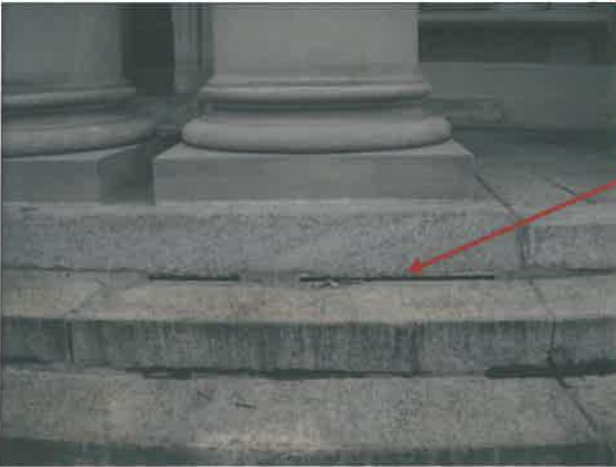
Upper main entrance stairs need to be repointed, and, in some instances, reset to prevent frost action from lifting and moving stone steps.

Category	Priority	Item Description	Cost
SC	2	Upper main entrance stairs need to be repointed and, in some instances, reset to prevent frost action from lifting and moving stone steps.	\$20,700
SC	2	Lower main entrance stairs need to be repointed and, in some instances, reset to prevent frost action from lifting and moving stone steps.	\$13,100
Item Subtotal			\$33,800

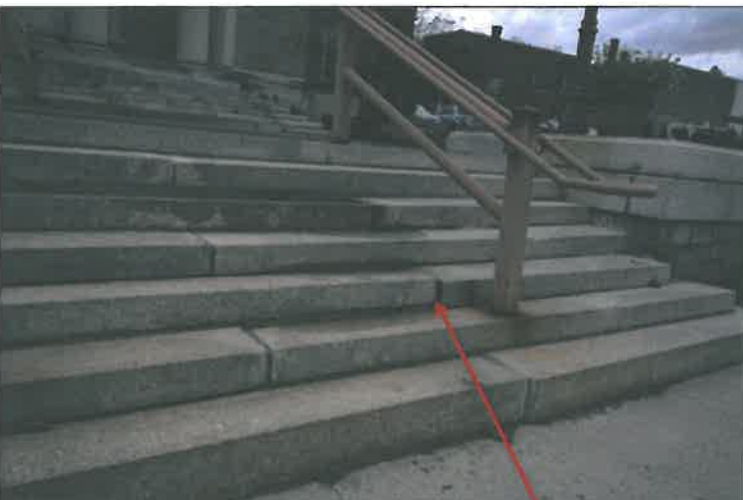
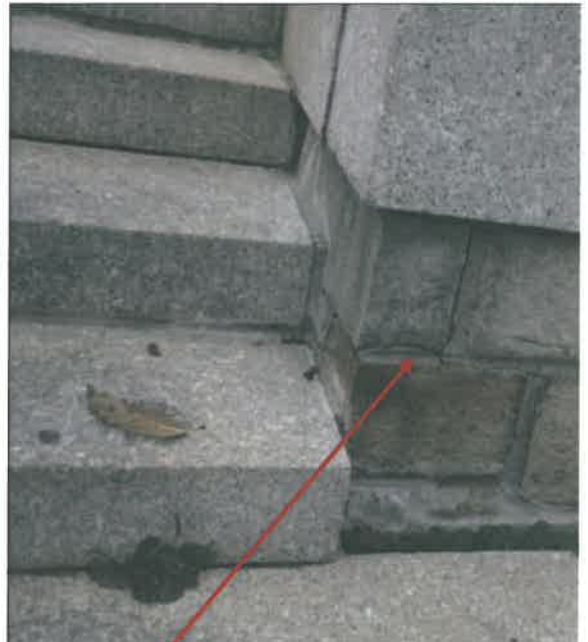
Lower main entrance stairs need to be repointed, and, in some instances, reset to prevent frost action from lifting and moving stone steps.

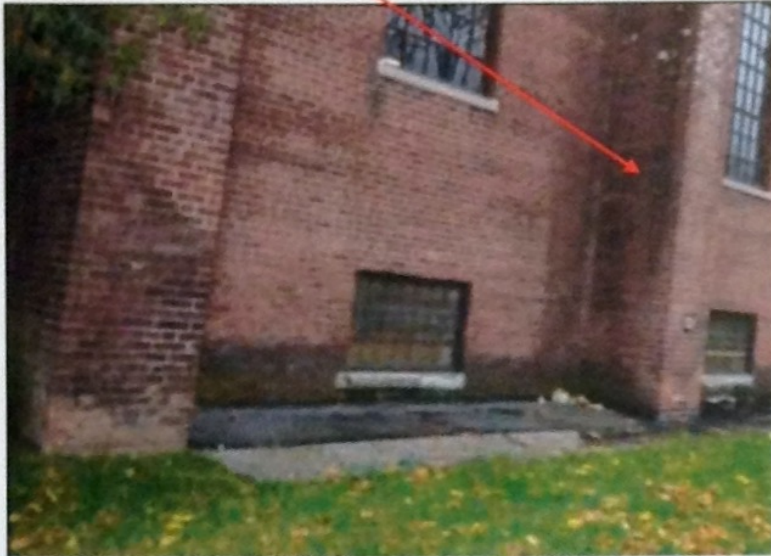
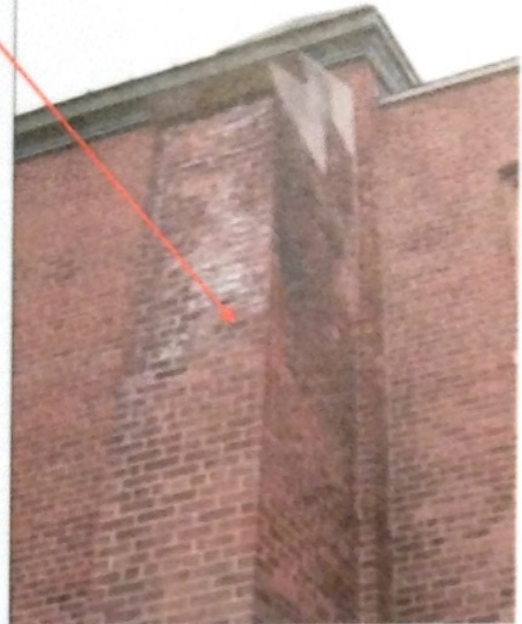
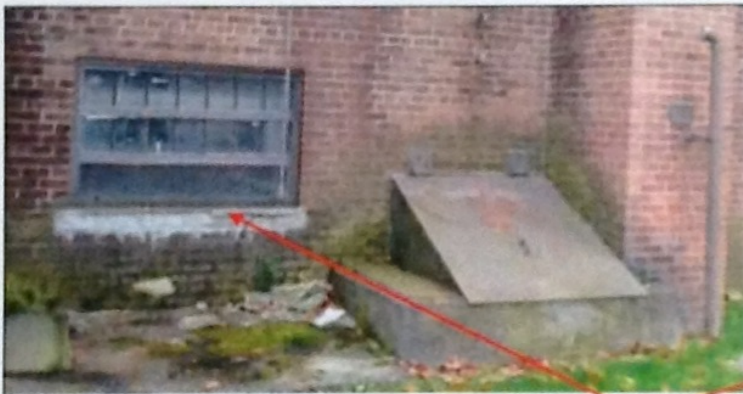
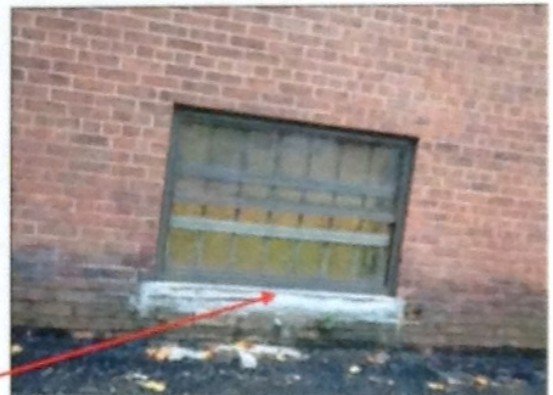
Repair and repoint brick work.

Category	Priority	Item Description	Cost
HSWP	2	Pipe Insulation appears to contain asbestos and, when verified, needs to be removed and replaced safely.	\$20,200
HSWP	1	Fire and smoke alarms need to be inspected and verified they meet Building Codes given occupancy uses.	\$2,200
CH	1	Handicap access needs to be improved given occupancy uses.	\$7,300
MS	2	Improved heating plant controls.	\$115,200
BE	2	Repair and repoint brick work and stone window sills	\$62,000
Item Subtotal			\$206,900

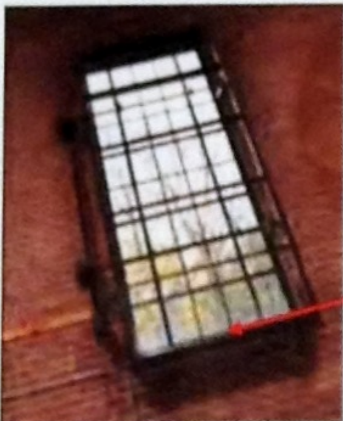
Repair and repoint stone sills

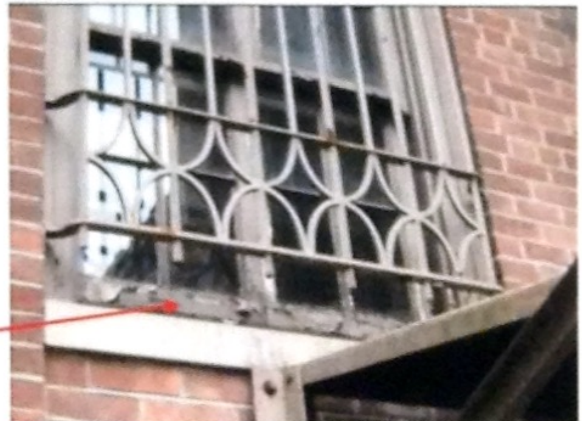
Windows need to be repaired and repainted especially in the gymnasium.

Category	Priority	Item Description	Cost
BE	2	Selected windows need to be scraped, caulked and repainted.	\$8,000
BE	2	Windows need to be repaired and repainted especially in the gymnasium.	\$21,600
EC	2	Caulk windows and doors.	\$14,200
Item Subtotal			\$43,800

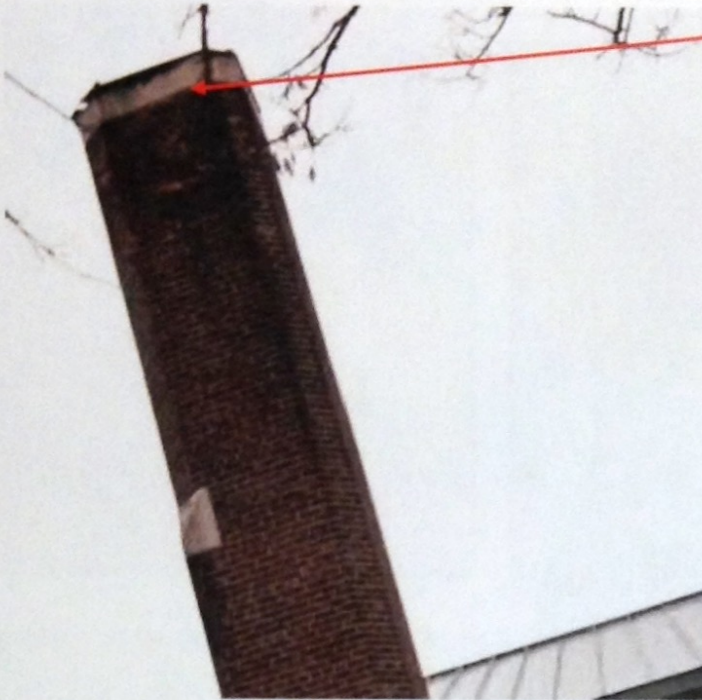
Repair or replace rusted chimney cap.

Category	Priority	Item Description	Cost
SC	3	Trim trees away from the building.	\$7,200
SC	2	Improve stormwater runoff and management.	\$20,000
BE	2	Repair or replace chimney cap.	\$2,300
SC	2	Improve grade conditions to protect building envelope	\$20,000
Item Subtotal			\$49,500

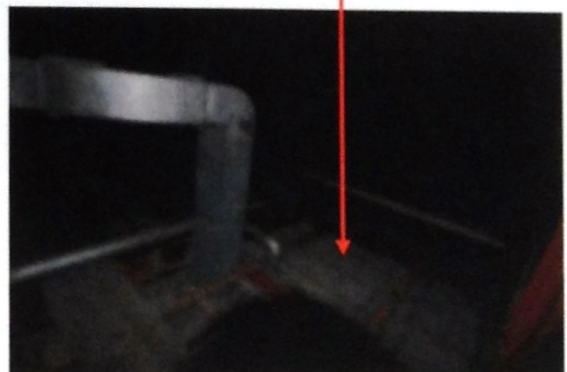
Insulate ceiling with cellulose and weather insulate hatchways to better control building temperature.

Category	Priority	Item Description	Cost
SC	1	Replace underground storage tank.	\$148,400
EC	2	Insulate ceiling/ attic space with high density spray foam	\$23,800
Item Subtotal			\$172,200

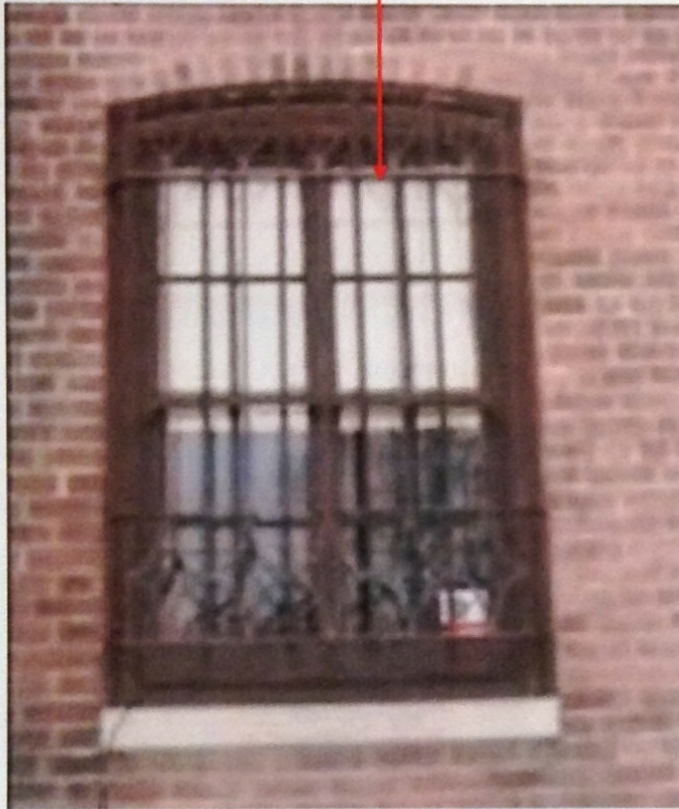
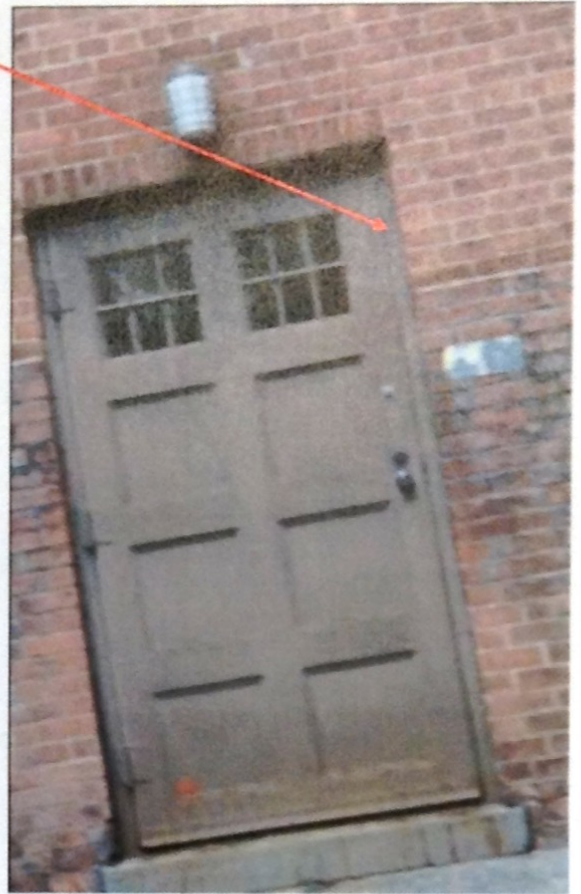
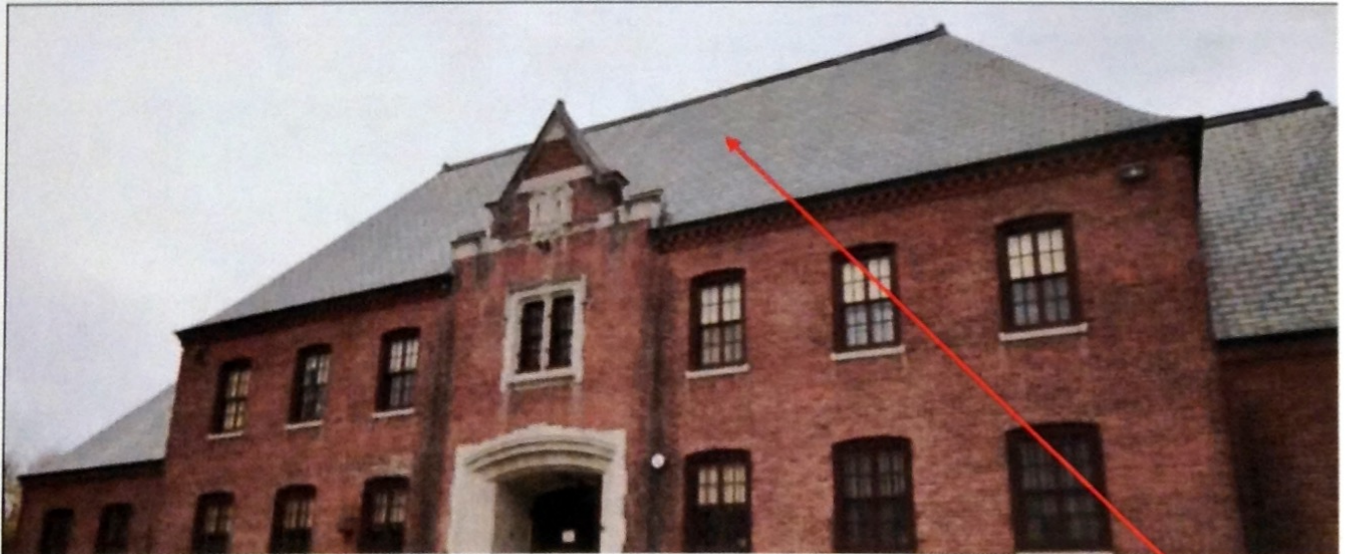
Door and window caulking

Some shingles are cracked but no reported leaks. Yearly inspections and repair where necessary.

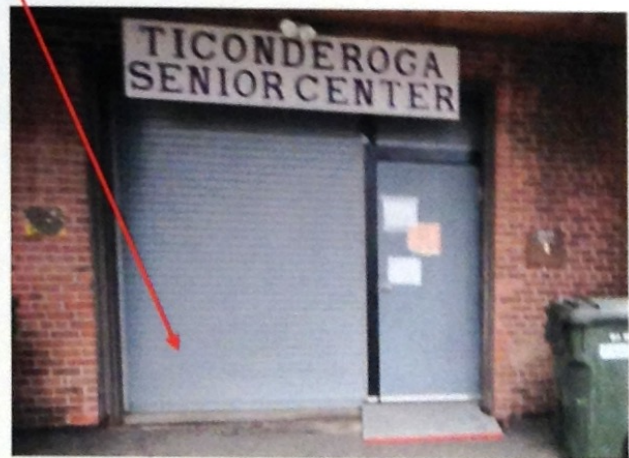
Renovate overhead door for better accessibility

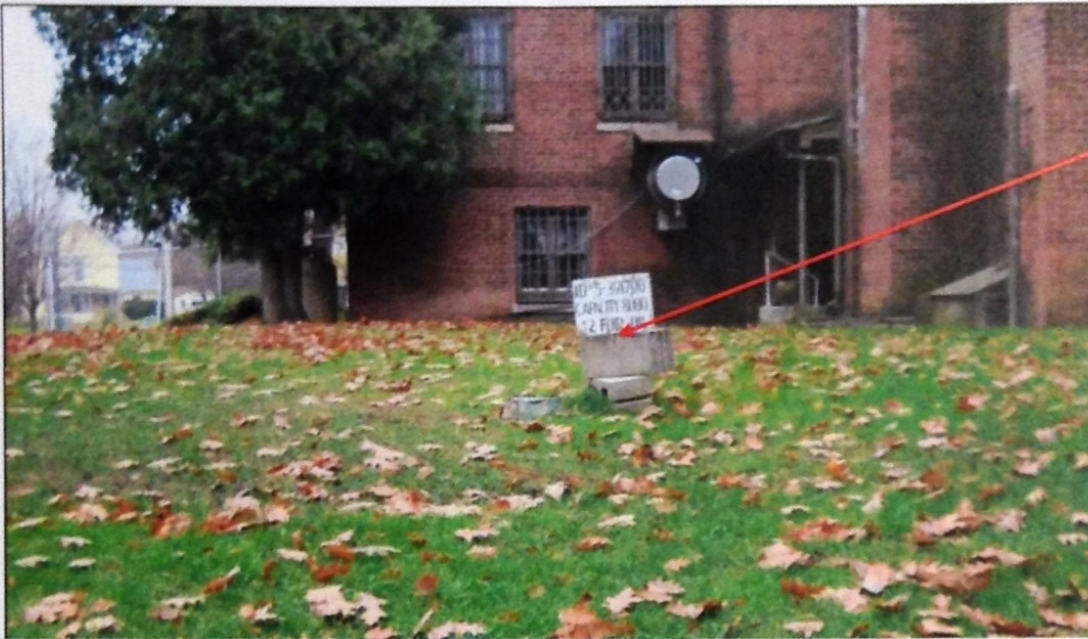
Remove and replace underground 8000 gallon fuel tank with interior tanks.

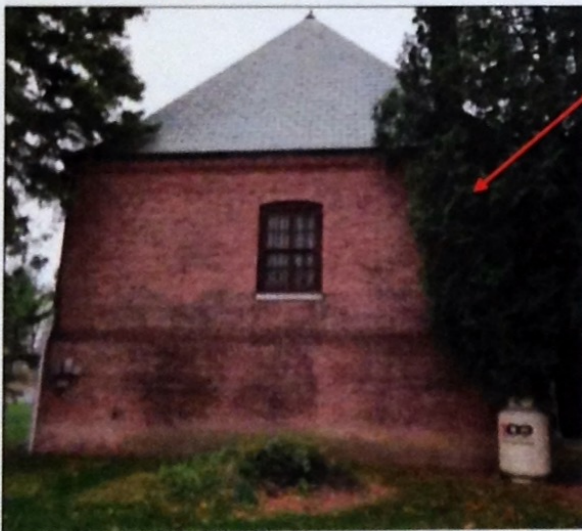
Trees should be trimmed so they do not lean against the building.

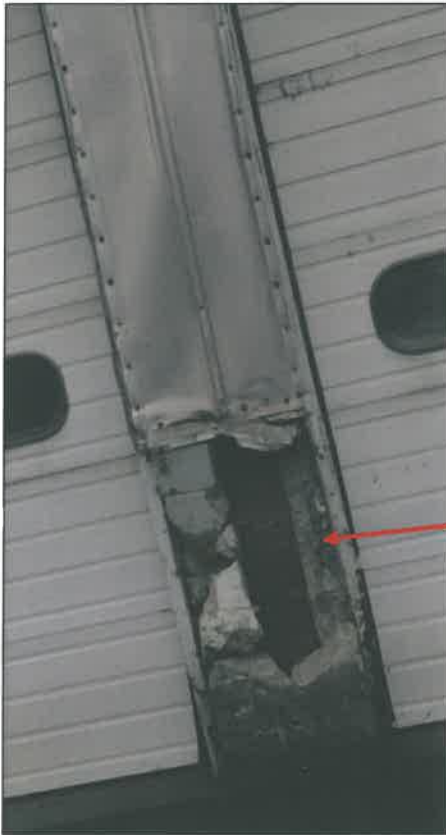
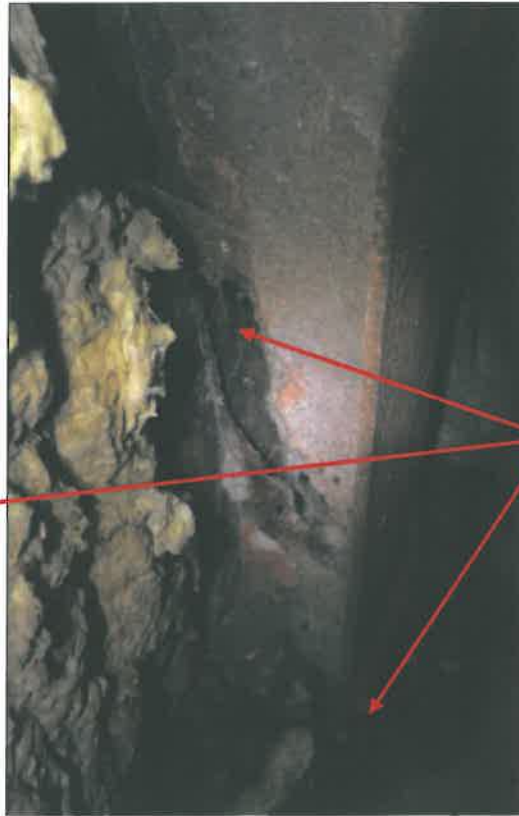
Replace or repair ridged metal frame and reinforce structural connections between the wall systems and foundation.

Repair wall and roof systems to keep them from leaking water and air.

Category	Priority	Item Description	Cost
BE	1	Provide temporary facilities for offices, equipment storage	\$100,000
BE	1	Reinforce structural connections between wall systems and foundation.	\$100,000
MS	1	Install adequate ventilation system.	\$40,000
HSWP	1	Provide additional storage to keep potentially harmful materials out of the working environment.	\$9,000
BE	1	Replace wall and roof systems to keep them from leaking water and air.	\$300,000
MS	1	Install adequate heating systems.	\$65,000
MS	1	Replace Plumbing systems.	\$30,000
MS	1	Replace lighting	\$60,000
BE	2	Reinstall and upgrade wall and roof insulation	\$60,000
HSWP	1	Provide adequate office and working spaces.	\$180,000
BE	1	Replace overhead doors	\$50,000
Item Subtotal			\$994,000

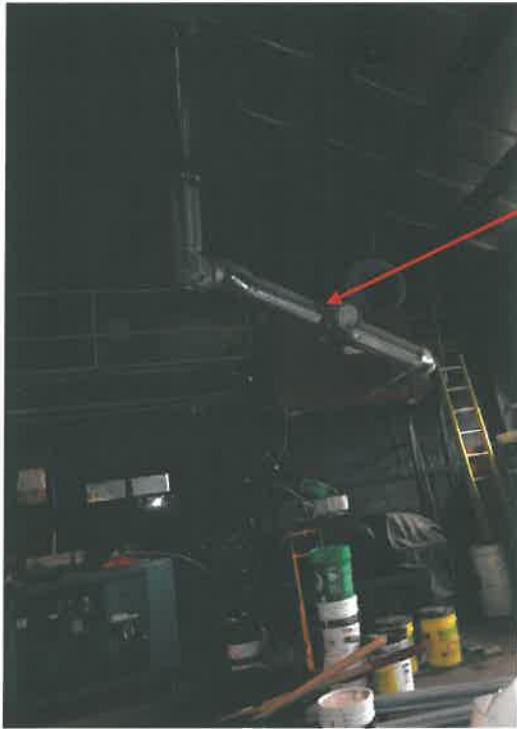
Install adequate heating and ventilation systems.

NOTE: Fresh air intake and exhaust systems are not adequate given the welding and repair activities being performed as well as the storage of solvents and fuels.

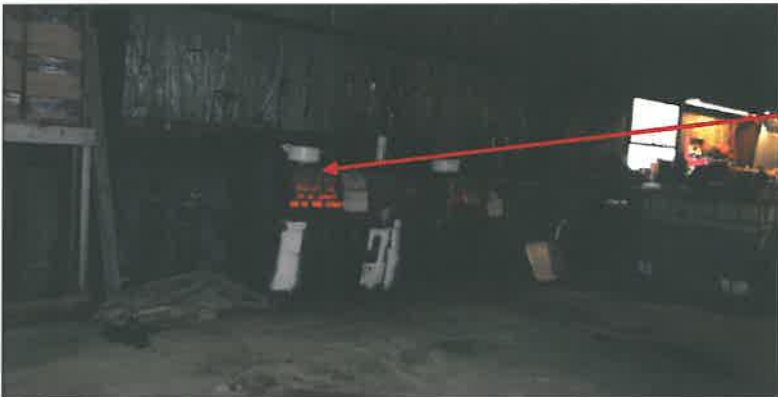
Provide additional storage to keep potentially harmful materials out of the working environment.

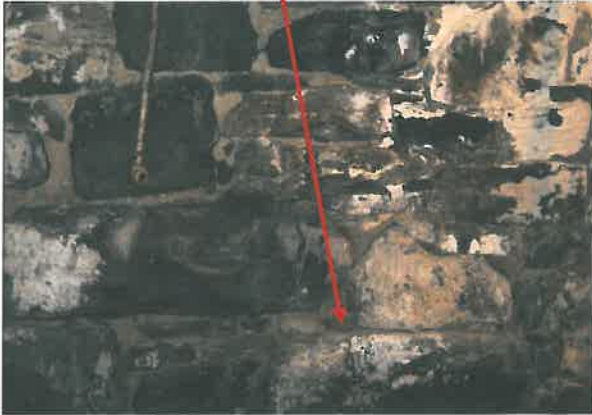
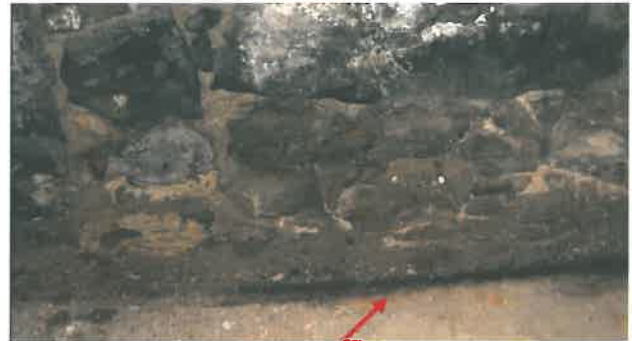
This foundation wall requires waterproofing and the redirection of water away from it as described below under "Site Conditions".

The stone and mortar foundation is passing water into the basement undermining its structural integrity and causing mold problems in the basement.

Category	Priority	Item Description	Cost
SC	2	Foundation drains on the parking lot side of the building and landscaping to direct water way from the building.	\$9,200
BE	2	Waterproof stone and mortar foundation wall.	\$1,200
HSWP	1	Install Building Code defined fire and smoke detection.	\$18,800
BE	2	Caulk windows and doors	\$8,500
Item Subtotal			\$37,700

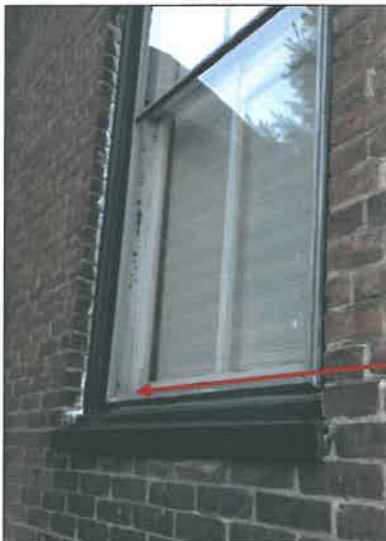
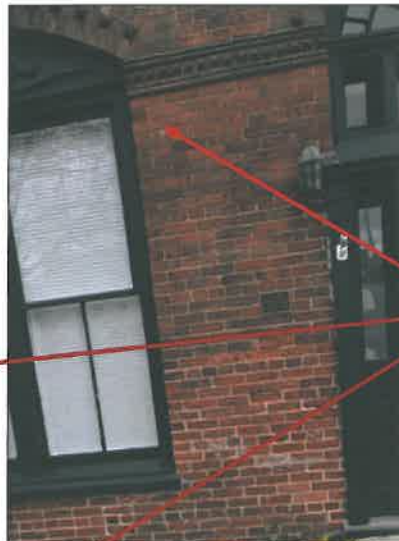
Scrape, caulk and repaint peeling windows.

Note: The water damage evident on the second floor caused by a leaking roof was remedied by the installation of a new roof in 2004.

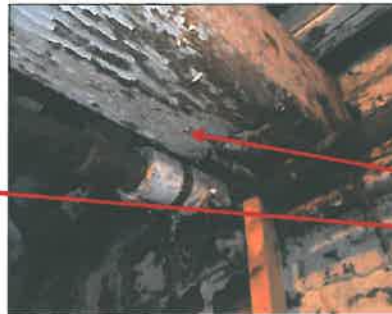
The pipe insulation in the basement appears to have asbestos in it and, when verified, needs to be removed safely.

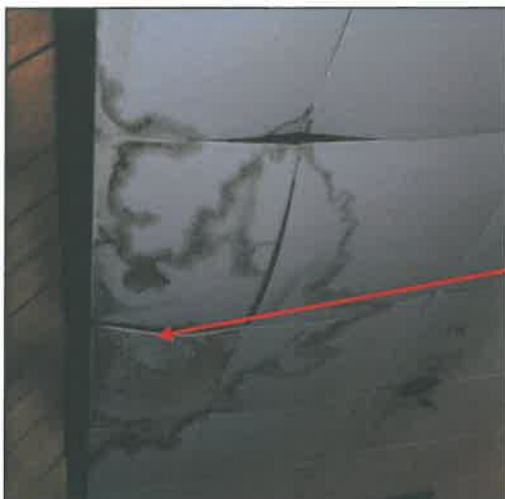
Ceiling tiles on the second floor date to when many contained asbestos. When verified, they should be safely replaced (which could be coordinated with the mold abatement).

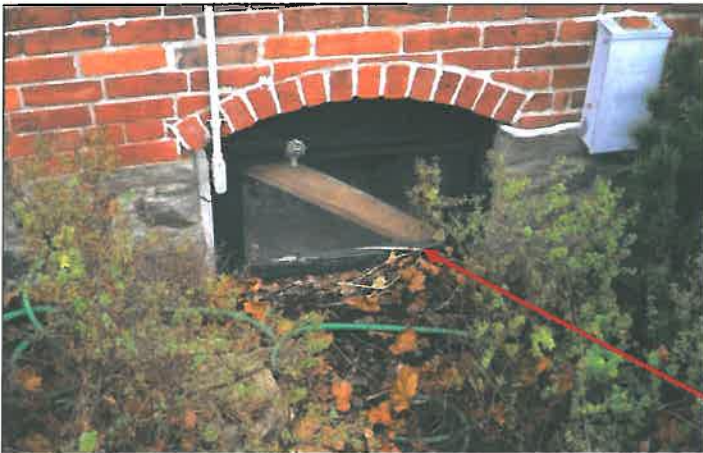
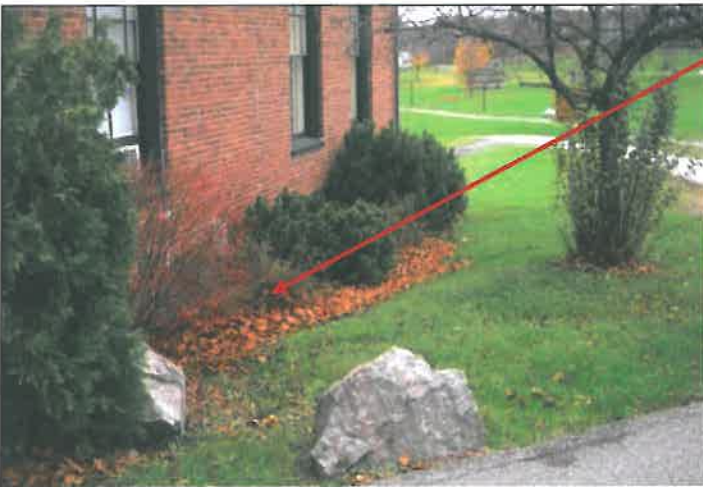
Hydrostatic pressure is being put on the stone and mortar foundation wall because of the grade of the lawn area near to the building

The adjacent parking lot which is directing water against this side of the building.

NOTE: Foundation drains and landscaping that encourages water down the slope away from the building should mitigate this problem.

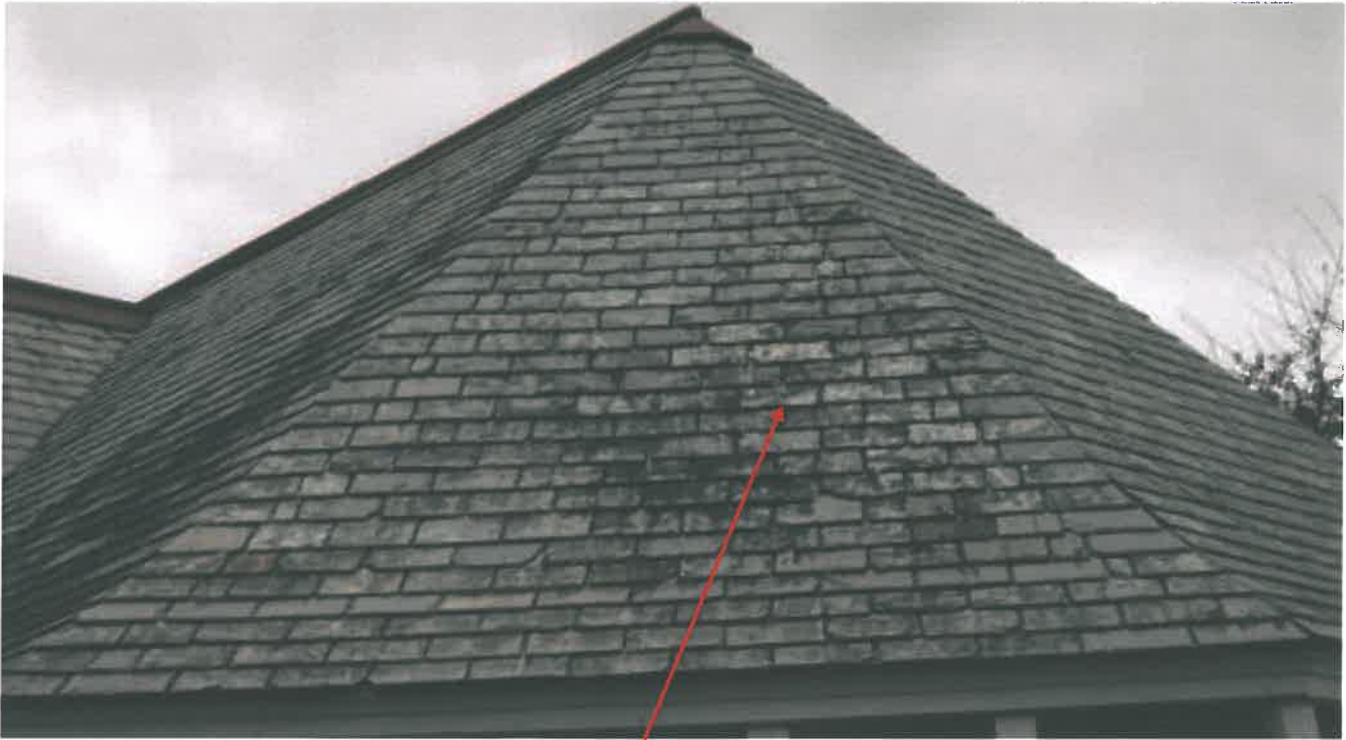
Replace slate roofing on the southeast section of the older section of the Library building.

Category	Priority	Item Description	Cost
BE	2	Replace slate roofing on one section of the old part of the Library.	\$5,800
Item Subtotal			\$5,800

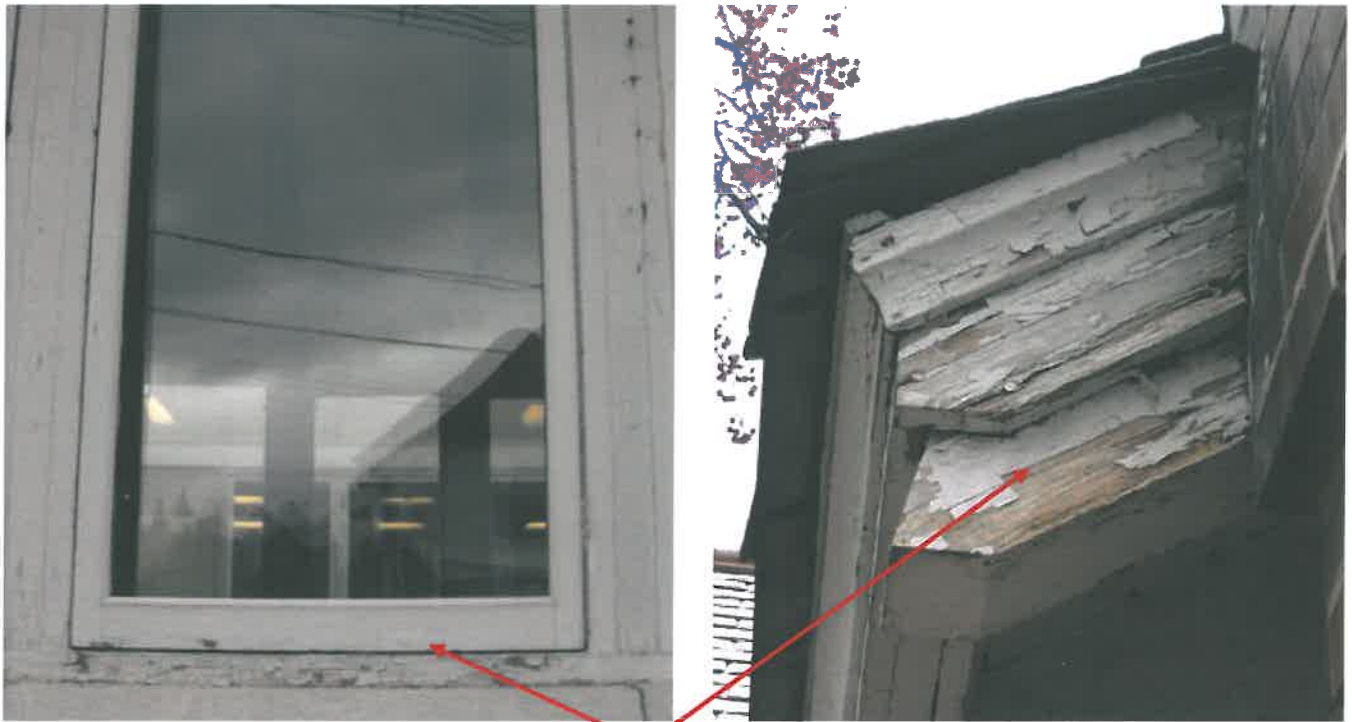
Scrape, caulk, and repaint peeling soffit and window areas

Category	Priority	Item Description	Cost
BE	2	Repoint mortar joints, where necessary, on brick façade on the older section of the Library building.	\$10,100
BE	2	Scrape, repair, caulk and repaint peeling soffit areas.	\$7,100
BE	2	Add gutters, where necessary, to the new section of the Library.	\$1,500
Item Subtotal			\$18,700

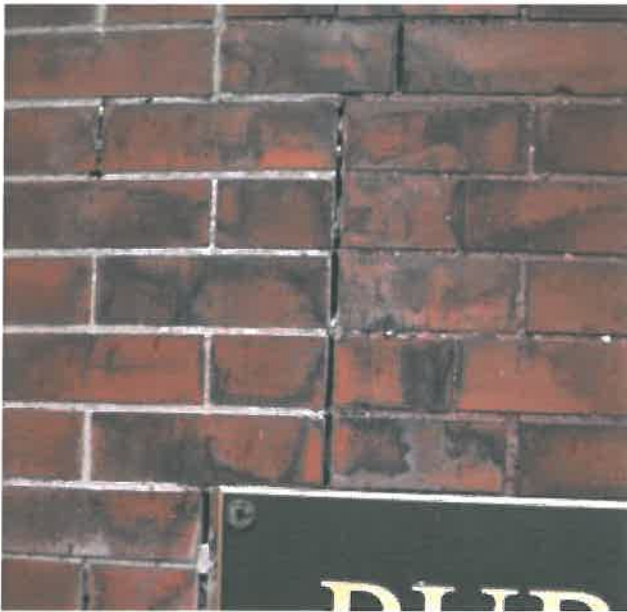
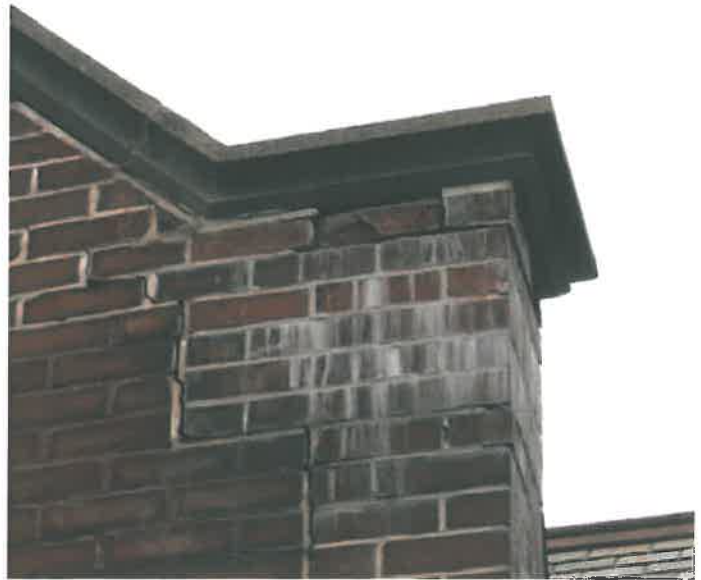
Short term: Repoint mortar joints, where necessary, on brick facade on the older section of the Library building.

Long term: Remove capstones and replace flashings for better water diversion

Category	Priority	Item Description	Cost
BE	3	Scrape, caulk and repaint peeling window areas.	\$7,100
BE	3	Replace cap stones and flashings on brick façade.	\$10,800
Item Subtotal			\$17,900

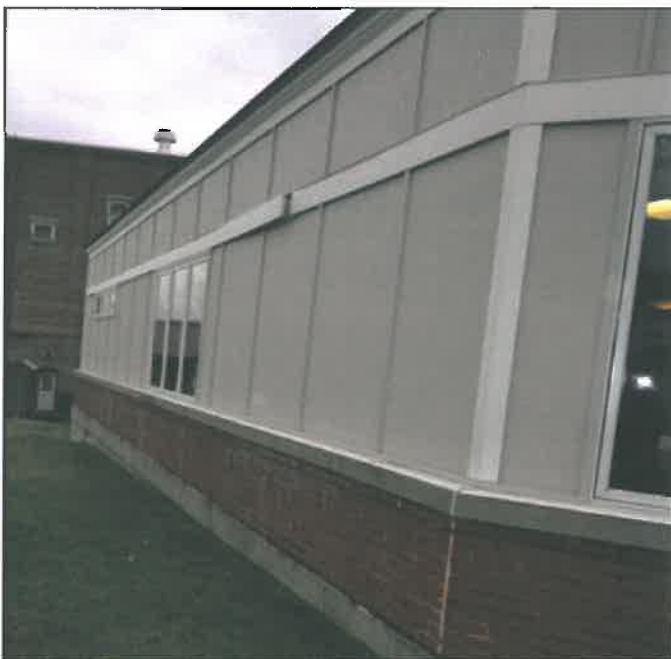
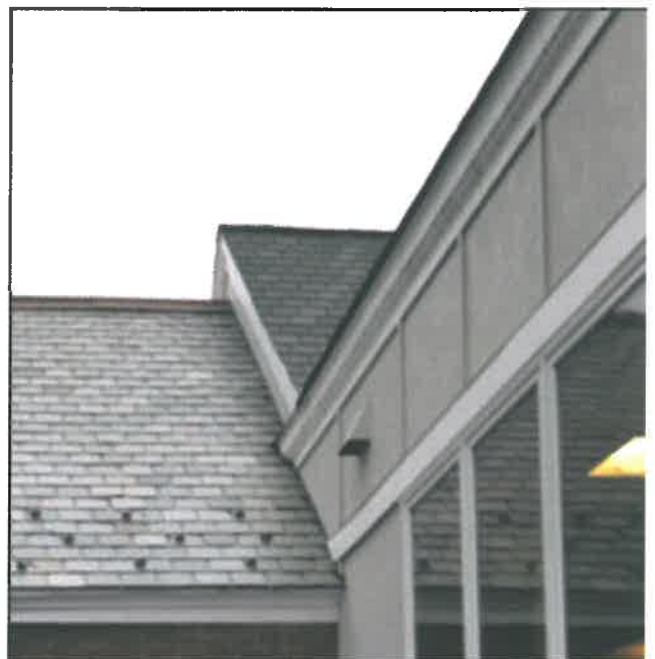
Add gutters, where necessary, to keep rainwater from the brick face and windows
